Manhole Inspection Summary

Manhole # S69C1_012MH

Insp Date: **2/12/08 9:54 AM**

Location Address: **Behind 6501 Detroit Ave. in alley** Cross Street: **Chesapeake Ave.**

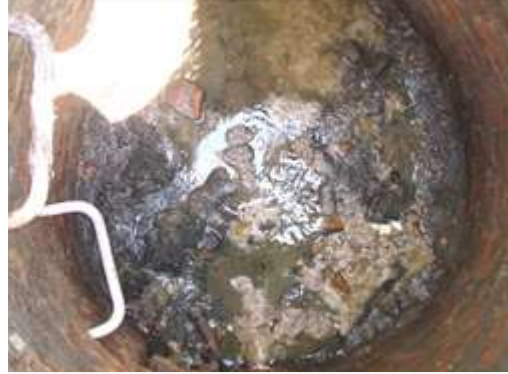
Top View

Comments **6 INCH PIPES. 7 O'CLOCK PIPE WAS CLOGGED AND AFTER DISLODGING THE CLOG, SEWAGE POURED OUT, FILLING MANHOLE 6INCHES.**

Chimney / Frame Adjustment ☒ Exists Material: **Brick** ☐ Parged Height: **4** (in.)
Condition: ☒ Sound ☐ Cracked ☐ Root Intrusion ☐ Loose Brick ☐ Deteriorated
Infiltration: ☐ None ☒ **Joint** ☐ Cracks ☒ **Mortar** ☐ Roots ☐ Wall
